FORM B - BUILDING

Form Number  
1095

Address 2318 Massachusetts Avenue

Historic Name Christopher Caldwell House

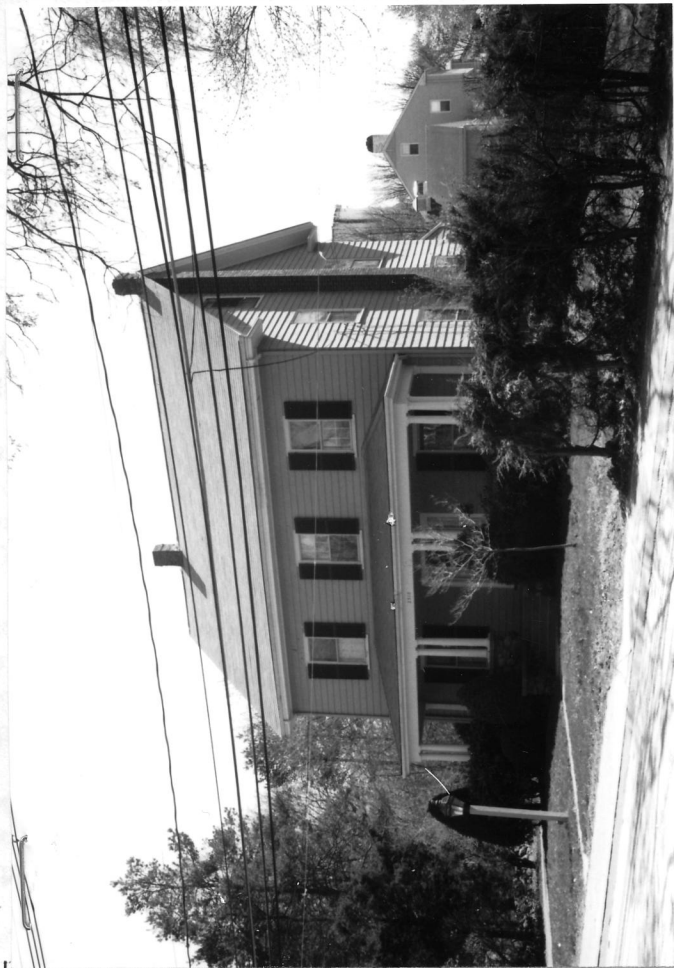
Located at the southeast corner of Mass. Ave. and Nickerson Road, 2318 Mass. Ave. is a 2 1/2-story, 3 x 2-bay dwelling which is sheathed in wood shingles and set on a brick foundation. The asphalt-shingled roof displays projecting eaves which end in returns on the side gables. A brick chimney rises from the east ridge with another brick chimney rising along the west elevation.

The facade is fronted by a full-width, hipped roof, single-story porch which dates to the early 20th century. It is supported by paired Roman Doric columns with sets of three columns at the corners, echoed by single pilasters against the house. The porch displays a concrete floor and stairs above a mortared stone base. The center entrance consists of a six-panel door with partial (2 x 4-light) sidelights set above raised panels. Most of the windows contain 6/6 sash with molded surrounds, metal storms and louvered shutters. On the west side of the house some of the original 6/6 windows have been replaced by modern 6/6 and 2/2 units. At the rear of the house is a shed-roofed, single story addition constructed in 1984. It is punctuated by a modern bay window and sliders.
